Analysis of the Stream Restoration Design of Donaldson Run Tributary B in Arlington, VA

December 2020

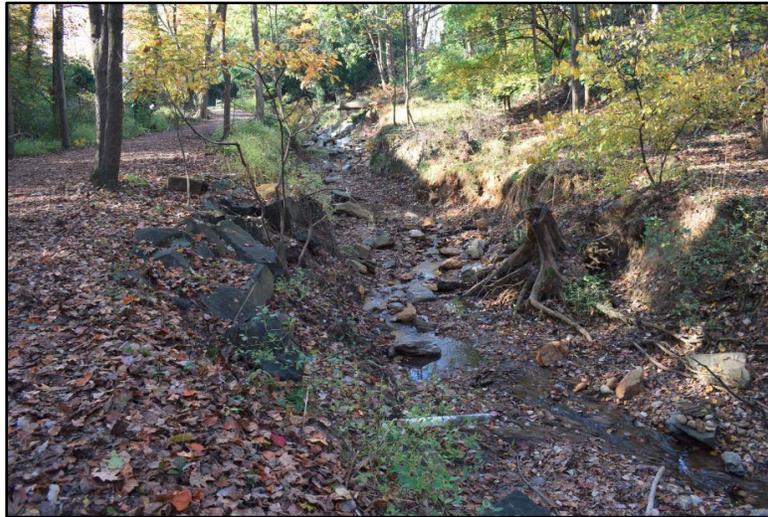
Figure 2. The upper portion of Tributary B has incised below the flat surface over which the stream once flowed.

The watershed draining to Donaldson Run Tributary B has impervious surfaces covering more than 26 percent of its area (VHB, 2019, Drawing number D-1). This has increased runoff to the stream compared to pre-development conditions while simultaneously reducing the amount of sediment available for transport. The resulting imbalance between the level of water and sediment entering Tributary B has engendered a channel response in the form of channel incision and bank erosion seen along the upper portion of the proposed restoration reach (Figure 2).

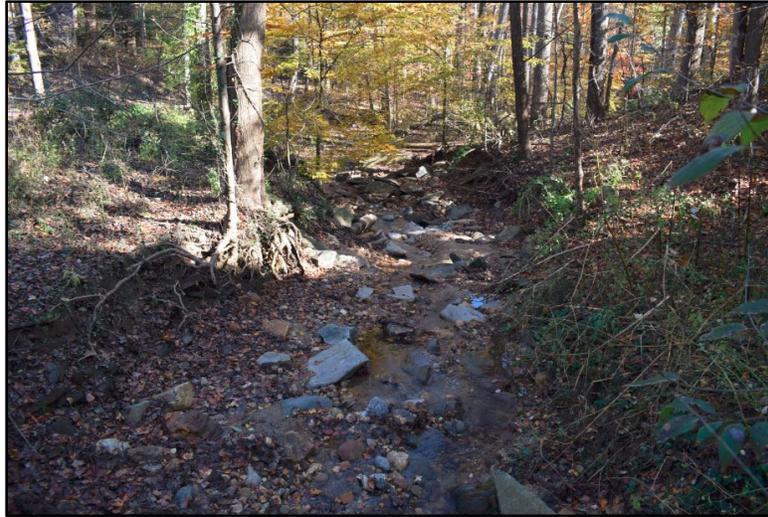
Figure 3. Tributary B is self-stabilizing near the footbridge with sediment accumulating on the channel bottom.

large rock from past bank stabilization efforts (Figure 3). Trees falling into the stream during this latter phase of bank widening have the potential to stabilize the bank and enhance aquatic habitat. Consequently, the area of the channel below the pedestrian bridge, while still eroding in places, is nearing a stable (but not static) condition in equilibrium with the urbanized watershed.

boulder structures often occurs in less than 20 years as is evidenced by the numerous isolated boulders found on the bed of Tributary B derived from past bank stabilization efforts (Figure 3).

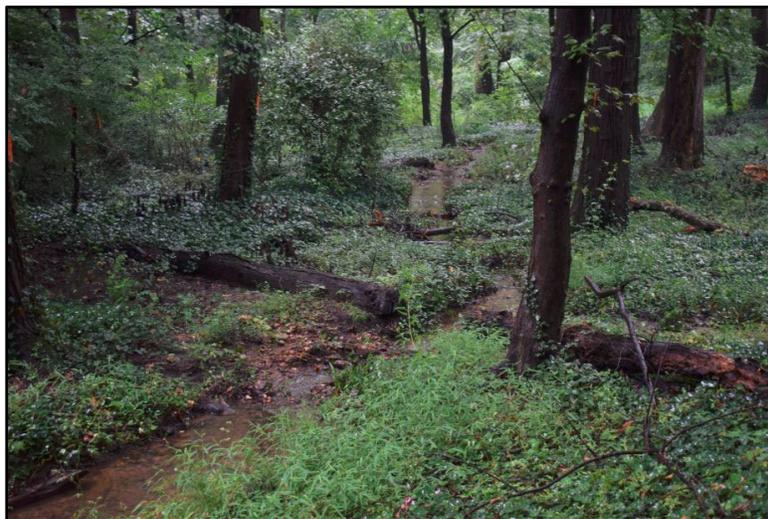
Figure 4. A small shallow channel flowing on an ancient valley bottom in the Hollin Hills neighborhood of Alexandria, VA is similar to how Tributary B likely looked prior to urbanization.

The upper part of Tributary B was likely much different prior to urbanization. No well-defined channel was present as the limited discharge from the small forested watershed likely spread out across the flat valley bottom (i.e., level of the walking trail) in multiple shallow flow paths (Figure 4). This flat narrow surface is not a modern floodplain, but rather the bottom of a large ancient gully carved into the high river terrace on which the adjacent residential homes are now built. The soils on this ancient gully bottom are millions of years old and support a forest community and ecosystem distinct from an active modern floodplain. Only with urbanization, did the discharge increase sufficiently to carve a channel into the ancient cohesive soils.

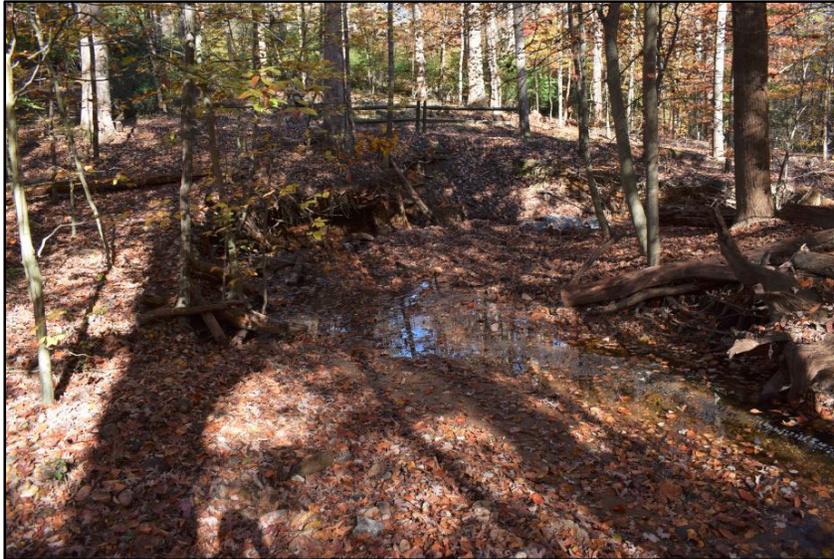
Figure 5. A highly sinuous meander on Tributary B near its confluence has remained relatively unchanged for decades as evidenced by the two large trees growing near the banks on both sides of the channel.

The lower portion of Tributary B becomes less confined and has likely changed very little since urbanization of the watershed. The loss of confinement is key in terms of the stream's ability to maintain the tight highly sinuous meanders in this section of stream (Figure 5) despite the increasing runoff from urbanization, because the flow can spread out over a wide area and limit the forces exerted on the channel's bed and banks. Although some minor changes are likely resulting from urbanization, the tight meanders have remained essentially unchanged since 1988 (oldest aerial photograph available on Google Earth) and likely much longer. These tight bends, therefore, are not an indication of inherent instability or evidence of rapid erosion, but are rather an expression of the natural equilibrium form for the setting.

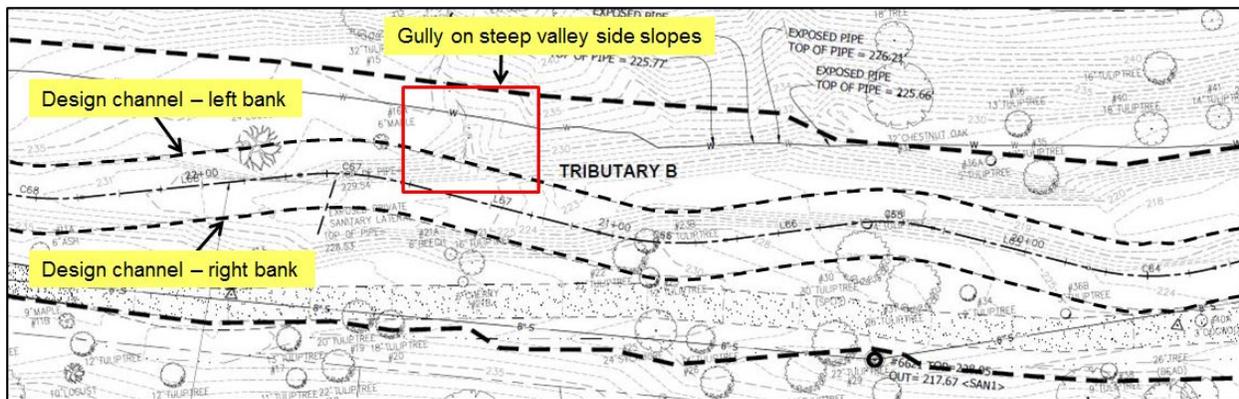
Figure 6. A portion of Drawing C-1 (VHB, 2019) showing proposed uniform meanders. Right and left bank are based on a downstream view with flow from left to right. The area highlighted by the red box is discussed in text.

The red box in Figure 6 highlights one of many locations where the design channel approaches the steep valley side slopes due to the lateral space needed to create the proposed meandering planform. At the highlighted location, a steep gully on the side slope will drain directly into the proposed channel and, as a result, could rapidly deposit large amounts of sediment. Such rapid inputs of sediment are unlikely along alluvial rivers that flow across a low floodplain, so the design (that essentially assumes Tributary B is alluvial) does not plan for such “outside” inputs of sediment and the proposed channel will be destabilized as a result.

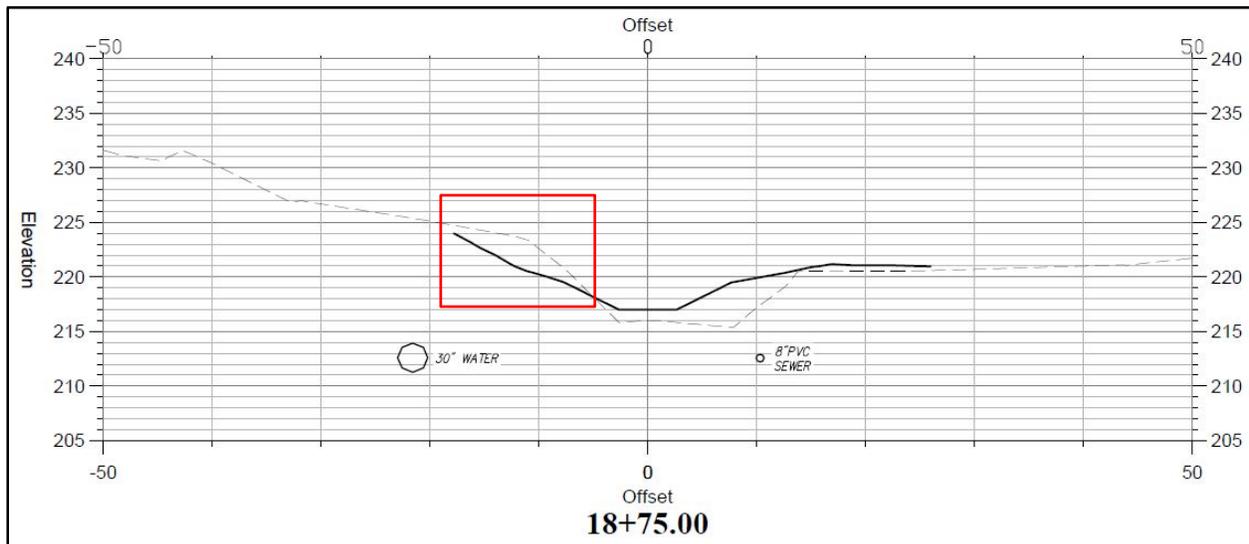
Figure 7. Cross section showing the proposed design channel (solid black line) will be excavated into the base of the high valley side slope (highlighted in red box). Note that the valley slope rises at least another 15 feet in elevation beyond the limits of the cross section. (From VHB, 2019, Drawing C-12)

Figure 7 is a cross section showing one location where the design channel will actually be excavated into the base of the steep valley side slope. This could destabilize the slope and trigger a landslide – a threat that will increase over time as flow in the design channel continues to impinge on and eat away at the slope. No evidence is provided in the design package (VHB, 2019) that documents a geotechnical analysis has been completed to determine the risk of such a landslide. The potential consequences of a landslide (or rapid inputs of sediment from the gully highlighted in Figure 6) would be to completely infill the design channel, allowing the flow to escape the design channel, reform a new channel elsewhere on the valley bottom, and cause the abandonment of the entire design channel downstream. This begs the question “Why does the design propose to form meanders in the upper confined section of Tributary B where no meanders ever existed before?” and also demonstrates that the primary project objective to stabilize the stream will not be achieved.

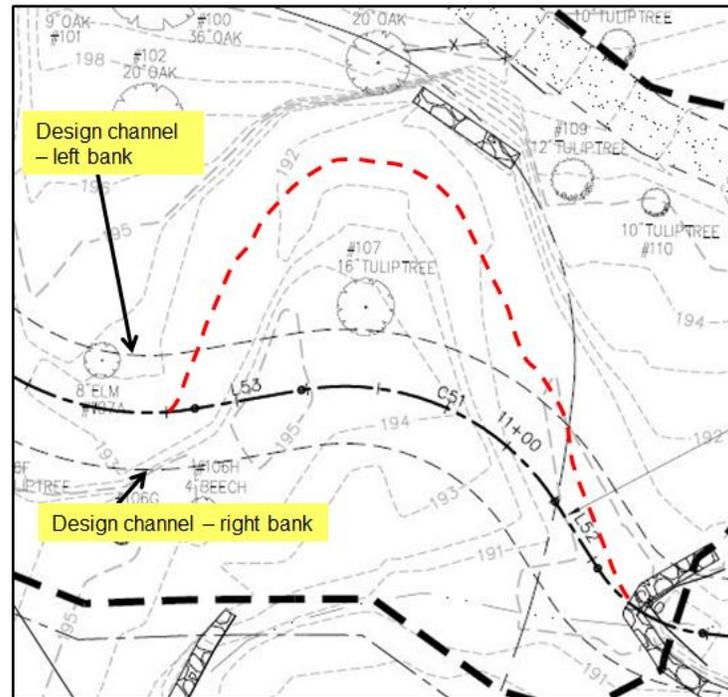
Figure 8. The lower sinuosity design channel proposes to cutoff the existing high sinuosity meander (centerline shown with dashed red line). (From VHB, 2019, Drawing C-2)

By maintaining essentially the same uniform meander shape throughout the project, problems at the downstream unconfined end of the project are also possible. The proposed design will cutoff one of the existing highly sinuous meanders (Figure 8) that, as described in Section 3.0 above, is the natural stable meander form for this setting. The proposed less sinuous meander, then, will be an unstable feature that will eventually be undone over time as the more sinuous meander

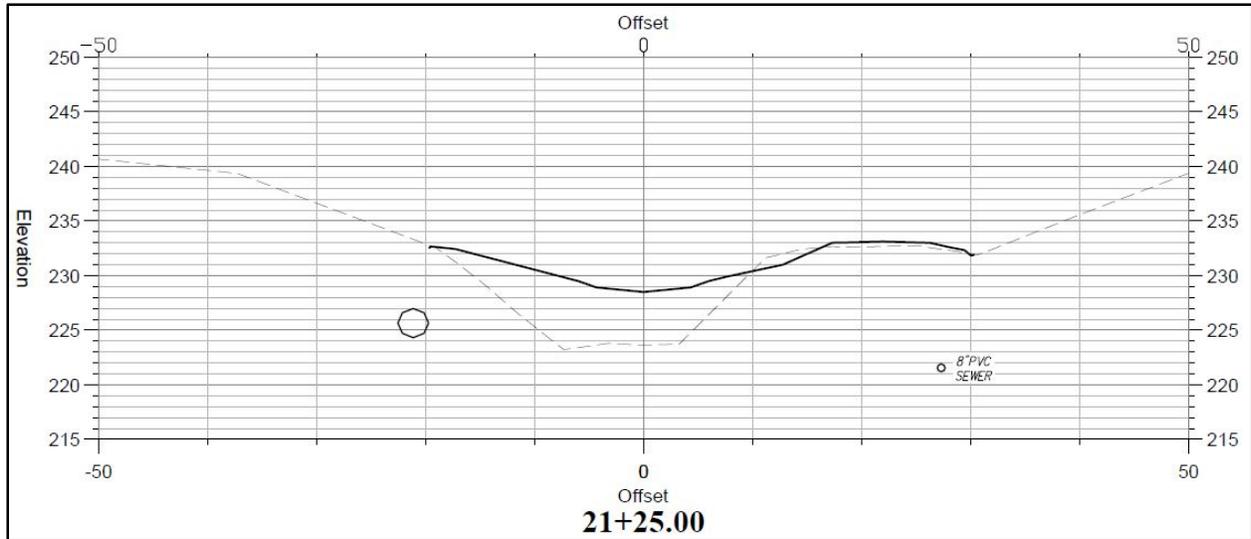
Figure 9. A typical cross section in the upper part of the restoration reach illustrating the difference in elevation between the existing channel (dashed line) and the proposed design channel (solid line). Fill will be needed where the solid line is above the dashed line. (From VHB, 2019, Drawing C-11)

VHB's (2019) restoration design proposes to fill, at least partially, the existing incised channel with what will presumably be a mixture of sand, silt, and clay (Figure 9). The amount of fill to be added is generally greater in the upper part of the proposed project with much less needed downstream where the existing stream is less incised. However, some fill is proposed for nearly the entire project's length. The cross section in Figure 9 is typical for the upper portion of the project with the depth of fill ranging from 5 to 7 feet depending on the position of the "thalweg" (i.e., deepest portion) and banks of the proposed channel. No details are provided in the design plans regarding the total volume, character, or origin of the fill to be used. The design justification for filling the existing channel with more than a thousand cubic yards of presumably imported fill is twofold: 1) to elevate the stream bed so that flows can more easily escape the channel and spread over the flat valley bottom in order to limit the stream power exerted in the design channel; and 2) to narrow the channel to approximate the expected width of an equilibrium channel in an undisturbed setting (with an adjustment factor added in recognition of urbanization as described in VHB, 2019, Drawing D-1).

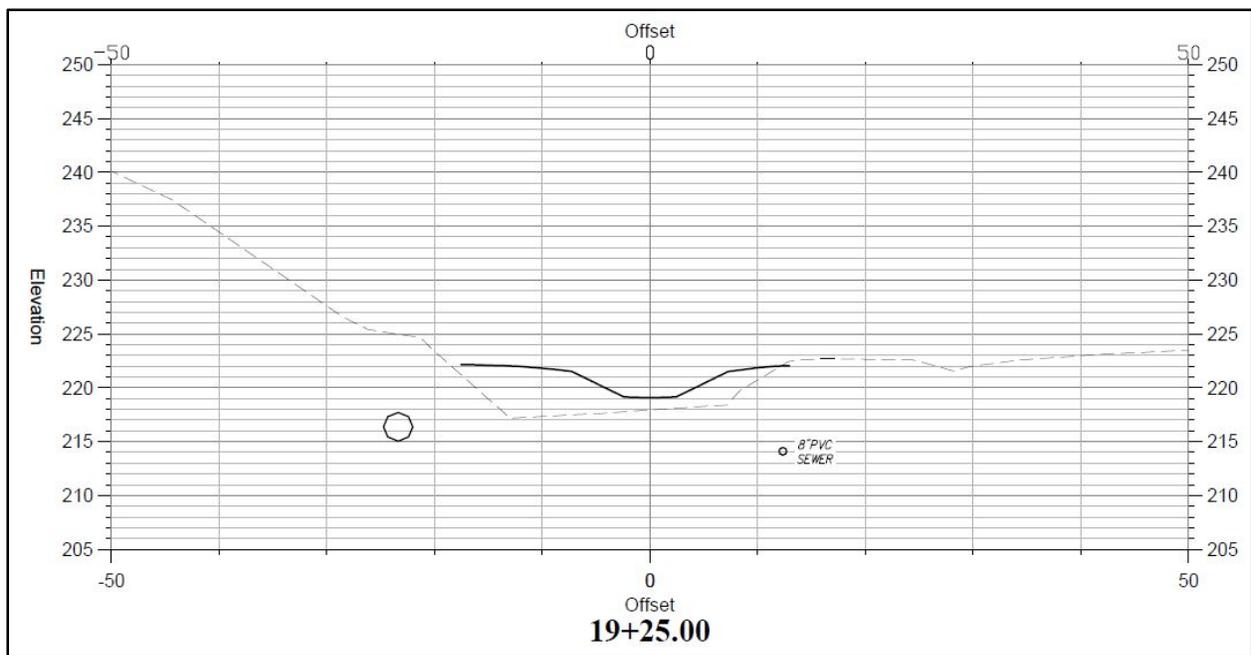
Figure 10. Cross section showing particularly well how fill placed in existing channel (dashed line) will create a narrower design channel (solid line) through most of the project’s length. (From VHB, 2019, Drawing C-12)

Elevating the stream bed by adding fill in the channel increases the stream’s gradient and, in turn, increases the stream’s capacity to carry sediment. The stream’s length in the project area is being shortened from 1,404 feet to 1,331 feet (VHB, 2019, Drawing C-3) due to planform changes like that shown in Figure 8, leading to additional slope increases. (Perhaps imperceptible to the human eye, streams trending towards an equilibrium condition are sensitive to even minor slope changes.) The fill is also being added to the existing channel to narrow its width (Figure 10). Squeezing the flow through a narrower channel, like putting a finger over the end of a garden hose, will further increase the flow’s velocity and ability to carry sediment.

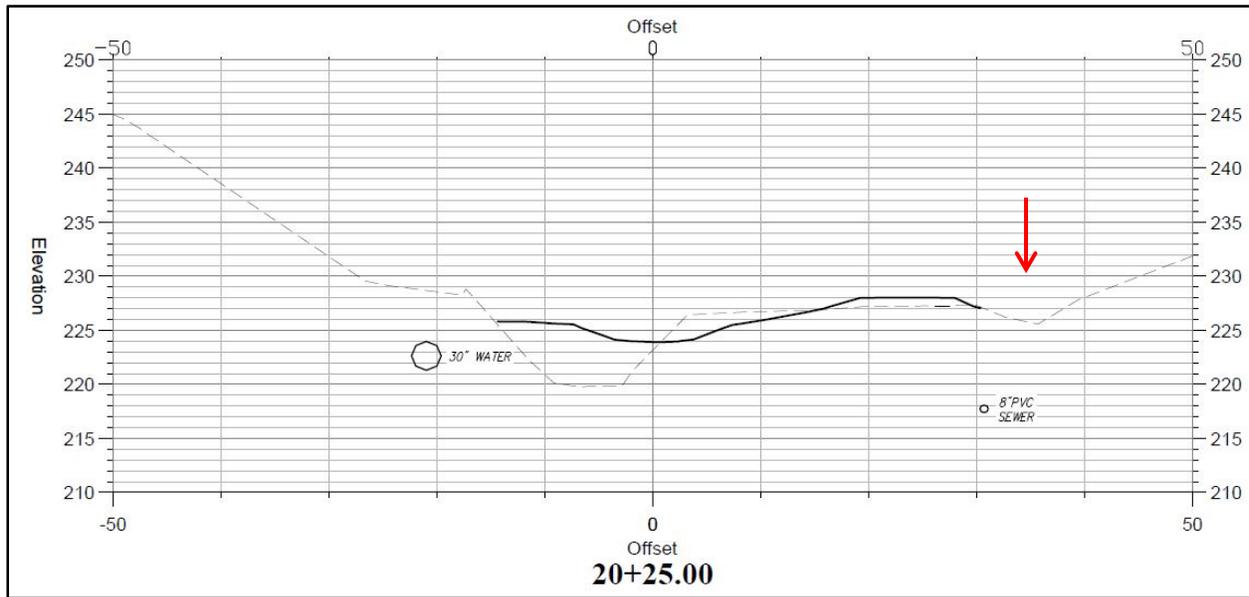
Figure 11. Cross section showing existing channel (dashed line) filled in to accommodate design channel (solid line), but leaving a low spot on the valley bottom (highlighted by red arrow) beyond the limit of disturbance. (From VHB, 2019, Drawing C-11)

The increased flooding of the valley bottom surface could have even more serious consequences as well. Where the design channel extends beyond the limits of the existing channel, the existing channel will be filled to the level of the valley bottom, but existing low spots on the valley bottom beyond the limits of disturbance will remain (such as the drainage swale along the walking path) (Figure 11). These low spots near the downstream end of the project are at times even lower than the bottom of the design channel itself (see VHB, 2019, Drawing C-16, Section 11+25.00).

The overbank flow emanating from the design channel will preferentially concentrate in these low spots on the valley bottom and could initiate channel incision to a depth lower than the design channel itself. In such an event, the design channel would be abandoned and the entire flow of the stream diverted to the newly incised channel. The potential damages from a new channel being carved on the valley bottom are significant as most of the existing low spots on the valley bottom are immediately adjacent to the sewer line. While the likelihood of such an event is low, dismissing a low risk event would be unwise given the potential high cost of repairs. By adding fill in the existing channel but leaving low spots on the valley bottom, the project could fail to meet its primary objective of stabilizing the stream and the project's explicit goal to protect adjacent infrastructure.

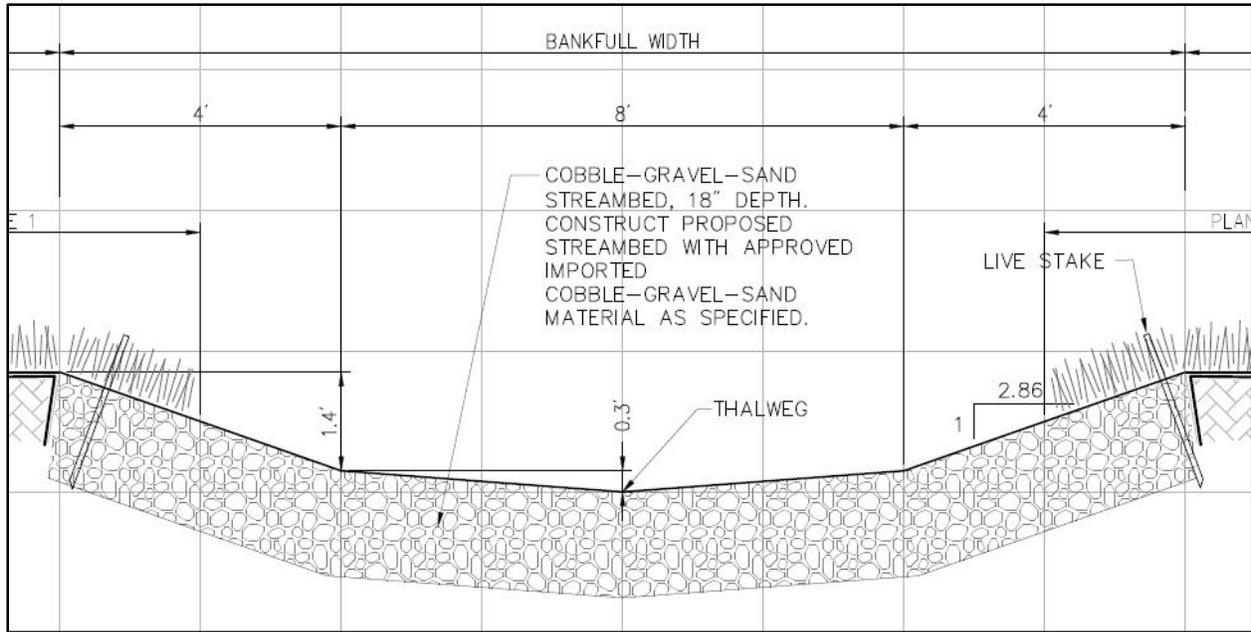
Figure 12. Portion of typical cross section showing 18-inch rock bed layer to be added to design channel along the length of the restoration project (From VHB, 2019, Drawing C-6)

Large rock is to be placed in the design channel in the form of an 18-inch thick bed layer across the entire channel bottom (and banks) throughout the length of the project (Figure 12). The “ D_{84} ” rock size to be used will have a diameter of 15 inches (i.e., a small boulder), which means that 84 percent of the rock will be smaller (including at least 10 percent sand) and 16 percent larger than that value (VHB, 2019, Drawing D-1). Much larger more rectangular boulders (with an intermediate axis diameter up to 5 feet) will be used to build a variety of step-like rock structures (VHB, 2019, Drawing C-4 and C-5) throughout the project's length (Figure 13). The justification for the coarse bed layer is to keep the stream bed and banks from eroding given that the sediment supply from the urbanized watershed is lower than in a more natural environment. The numerous boulder step structures are justified as “grade controls” (i.e., to prevent downcutting of the channel) and habitat features.

The rock size used in the 18-inch thick bed layer has been carefully selected to remain immobile up to a 10-year flood event (VHB, 2019, Drawing D-1). What will happen, however, during an even larger flood when the bed layer is able to move? With only finer-grained fill underneath the coarse bed layer (see Section 4.2 above), the implication, perhaps expectation, is that the design channel could be enlarged through bed and bank erosion with the currently existing gully

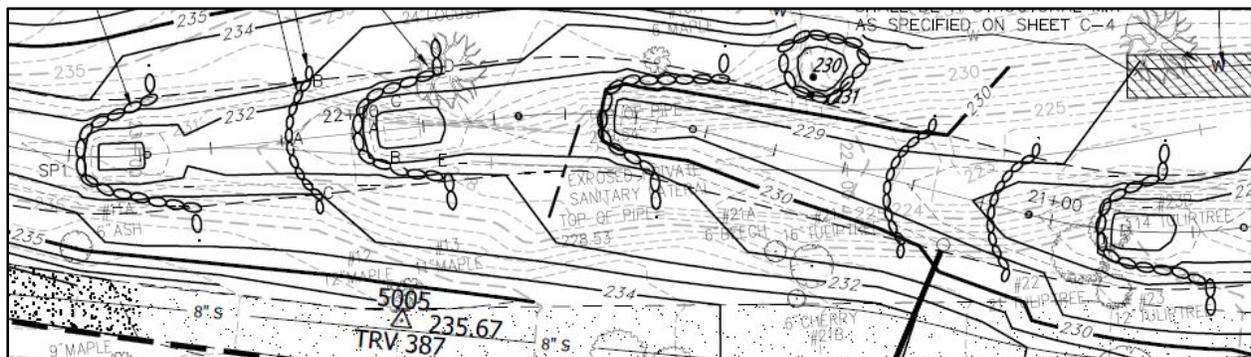
Figure 12. Portion of design plan showing several of the boulder step structures to be built across the proposed channel along its entire length. (From VHB, 2019, Drawing C-7)

The use of the large boulders to form the rock step structures also presents problems. Boulder steps are natural features found on confined and steep mountain streams. While the upper portion of the restoration reach on Donaldson Run Tributary B is confined and fairly steep, the soils are largely composed of fine-grained material with no boulders occurring naturally. When stream flows encounter a contact between large immobile boulders and fine erodible sediment, the stream will preferentially and aggressively scour the fine sediments on the bed or banks of the channel. Since the boulder steps will be set below the coarse bed layer (VHB, 2019, Drawing C-5), undermining of the structures seems less likely than the “outflanking” of the structures (i.e., lateral erosion around the steps) due to bank erosion. Similar outflanking of boulder structures occurred as a result of bank erosion along the design channel constructed as part of the nearby Donaldson Run Tributary A restoration completed in 2006 (Figure 13).

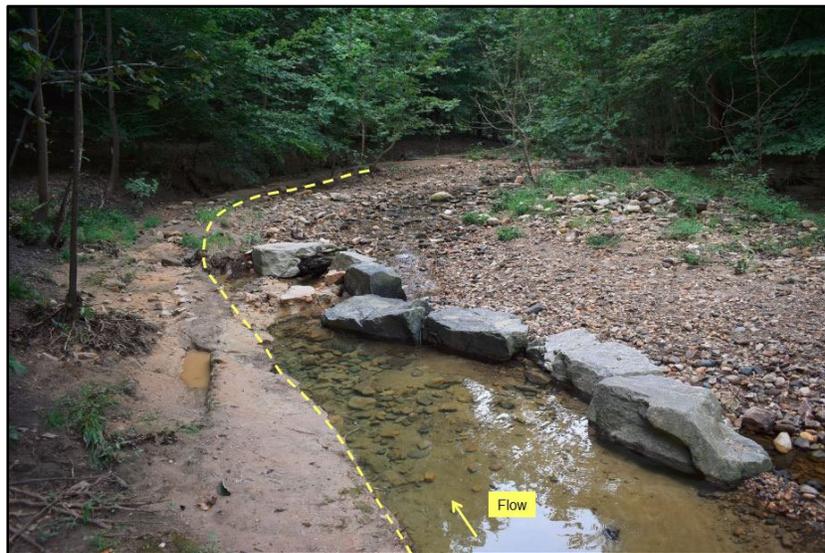
Figure 13. Outflanked boulder structure installed as part of Donaldson Run Tributary A restoration. Dashed yellow line approximates position of bank at completion of construction but is now well within the channel limits such that the boulder structure is not functioning as intended – note gravel bar against the boulders where a pool should be.

Again, this is not hyperbole but exactly what has happened along the immediately adjacent restoration project on Tributary A (Figure 13) and other projects in the mid-Atlantic region (Miller and Kochel, 2010). Why are so many large boulders being used in a Natural Channel Design project at a site where no boulders exist naturally? The ability to sustainably achieve the project goals on Tributary B will be greatly compromised, not enhanced, by the use of boulders to create step-like structures.

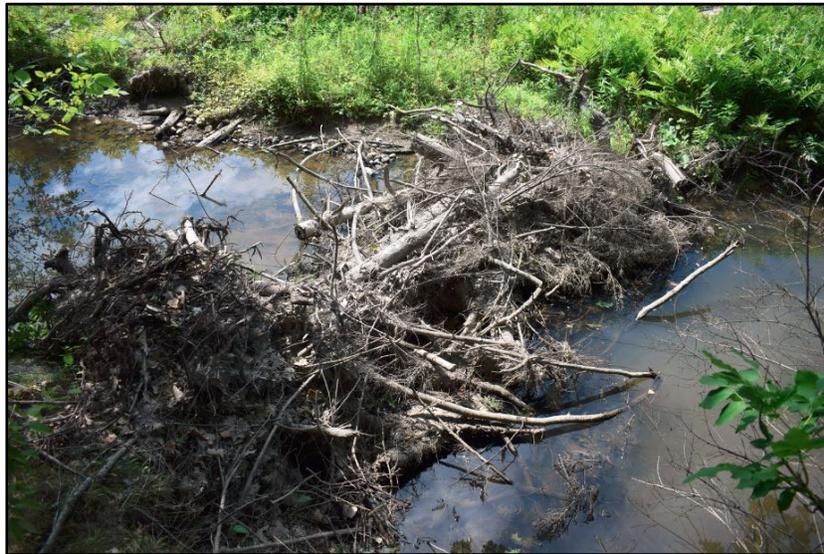
Figure 14. Low log jam structure built for an urban stream restoration project in South Portland, ME. Such log jams on Tributary B would extend only partially up the high banks and could be used to dissipate the high energy flows emerging from the culvert outlet at the upstream end of the project.

Wood could serve at least four different functions as part of Tributary B restoration: 1) energy dissipation; 2) bank stabilization; 3) sediment storage; and 4) habitat enhancement. Just downstream of the upstream culvert outlet where the current restoration design envisions a series of rock plunge-pool structures to dissipate the energy of the runoff exiting the culvert (VHB, 2019, Drawing C-7), low log jam structures (Figure 14) spanning the channel could more effectively dissipate energy while providing greater habitat function. In addition, the log jams would be more porous, so pools of water during low flow conditions would not persist as potential mosquito breeding areas. The banks of the channel around these log jams could be stabilized with some form of log crib wall (Figure 15) that would better resist scour and undermining than the currently proposed rock walls if vertical log piles are used to anchor the log cribbing.

Wood added to the channel for the purpose of sediment storage along Tributary B could take the form of low log jams (Figure 14) or random placements of large logs to appear like natural tree fall. Sediment would be stored upstream of the log structures and when filled to the top of the logs could create step-like structures with plunge pools forming downstream as envisioned for the boulder steps in the current design plan (VHB, 2019). Furthermore, the sediment storage, over time, leads to channel narrowing in a sustainable manner (Figure 16b) as opposed to the Natural Channel Design proposal (VHB, 2016) that is unlikely to maintain the constructed narrow channel (see Section 4.2 above). Wood would be best placed where bedrock has been exposed, since a stream bed composed of gravel and cobble would be better for macroinvertebrate colonization than sheer rock. However, wood structures promoting sediment storage and energy dissipation would be beneficial throughout the length of the project.

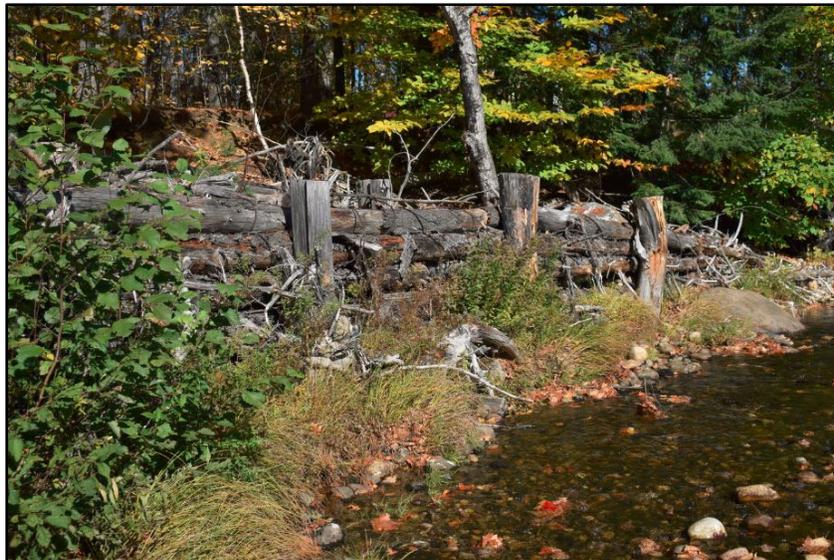
Figure 15. Log crib wall constructed for bank stabilization on Sunday River in Newry, ME. Photo was taken 14 years after construction and is unchanged since completion and remains solid. Rot resistant hemlock used.

Log crib walls could also be used for bank stabilization elsewhere along the stream. However, the entire length of the stream does not need to be stabilized. Bank stabilization should be reserved for only where critical infrastructure is most threatened. Only by allowing the channel to finalize its natural widening process (see Section 2.0 above) will the stream be able to reach an equilibrium condition in balance with the urbanized watershed. However, given the proximity of critical infrastructure, most of the restoration reach upstream of the pedestrian bridge may require bank stabilization. Log crib walls with roots protruding slightly out from the bank would further dissipate the energy driving the erosion in contrast to the current restoration proposal with stream-lined meanders and smoothed rock banks on a slope steepened by the addition of fill. Downstream of the pedestrian bridge, very little need for bank stabilization exists as the stream has essentially completed the widening process (Figure 3), the highly sinuous meanders near the confluence (Figure 5) have changed little in more than 30 years, and the critical infrastructure is not as proximal to the existing stream banks.

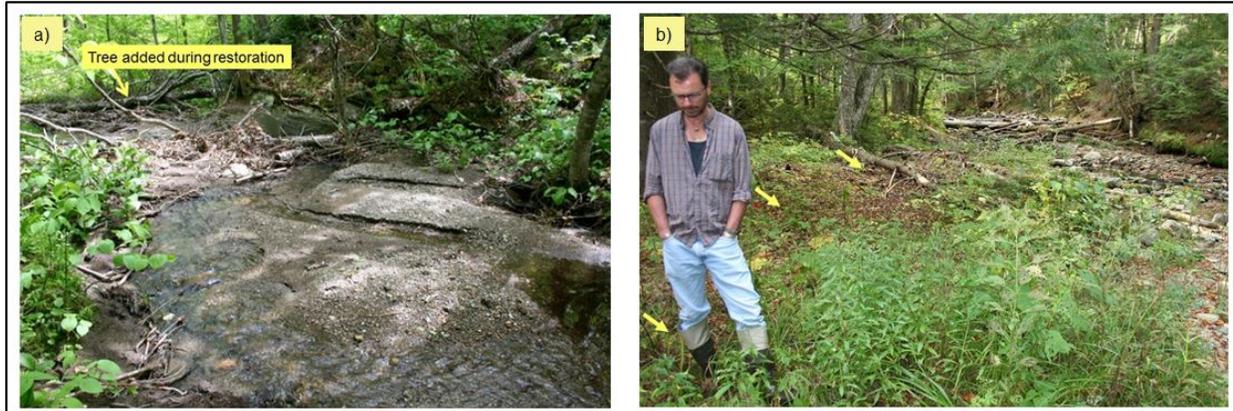
Figure 16. Wood addition projects on two small streams in the Green Mountain National Forest, VT. Photos taken a) one year after completion and b) 20 years after completion (arrows at edge of channel prior to wood addition). Note considerable sediment accumulation following one year and how after 20 years a revegetated floodplain developed as the channel narrowed as a result of the sediment storage.

One motivation for completing restoration on Tributary B is to earn “credits” for reducing sediment loading downstream to Chesapeake Bay. The method used to justify the credits for the current design is by calculating the amount of sediment prevented from entering the stream by stabilizing the banks. While this should still apply for bank stabilization using log crib walls, additional credits could be earned using wood to encourage sediment storage along the stream bottom. Wood placed across the channel can store a considerable volume of sediment and help narrow the stream channel (Figure 16). Skalak and Pizzuto (2010) demonstrated that fine sediment and organic matter can remain in storage for decades behind large wood in rivers, significantly reducing the annual sediment load moving downstream. Wood placed periodically along the existing stream channel helps to build resilience against large floods and rapid sediment inputs by providing both energy dissipation (that reduces erosive forces when flows are high) and sediment storage capacity (that provides a buffer to downstream sediment transport when sediment inputs are high).
